Gazette Fire Ignition

17 March 2018

**Tree failure 992 Twomeys Bridge
Road, Yatchaw**

Technical investigation report

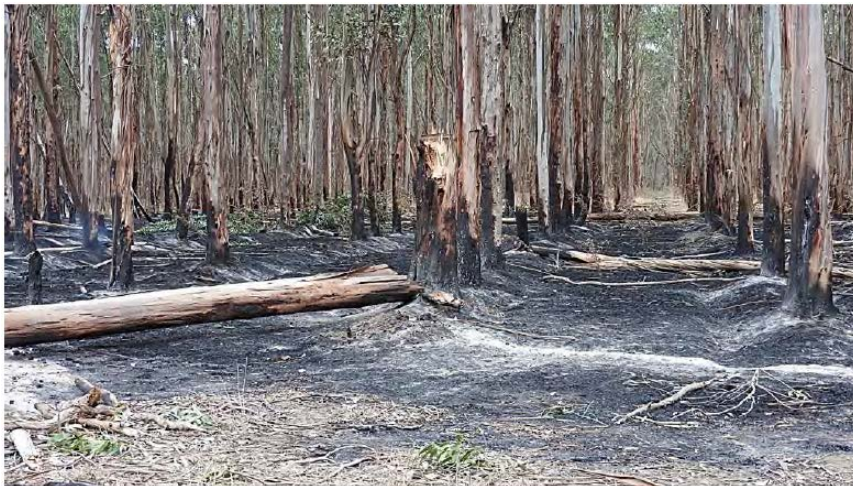
Figure 3: Tree stump failure point

- a tree base had been cut to near ground level; it was assumed to be the remaining tree stump as displayed in Figure 2 above
- a tree was cut into sections lying on the ground that appeared to be the one suspected to have contacted the overhead line (*It was subsequently confirmed that these were the sections of the failed tree*)

- the combined length of these sections was measured at 27.0 metres. The stump in the picture above was measured at 1.5 metres in height. This means the estimated height of the tree would be 28.5 metres

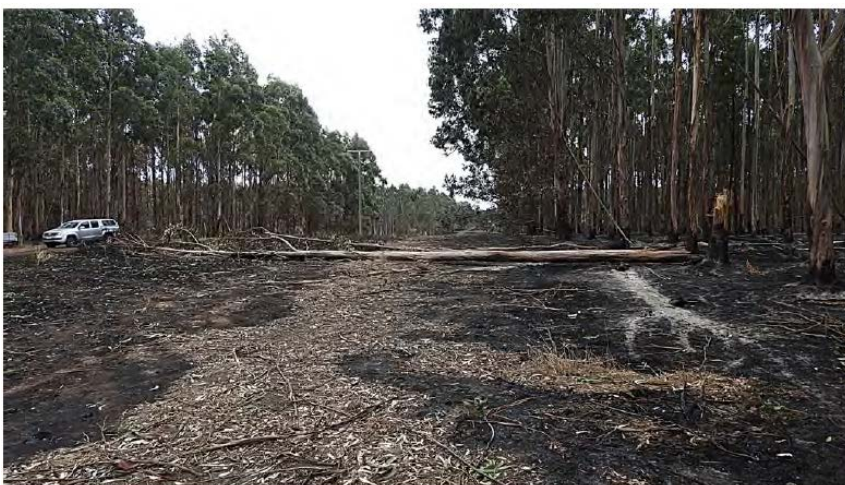
Figure 4: Tree failure complete section

- the distance measured from the tree stump to the closest HV conductor was 22 metres
- the tree fell in the direction of the powerline
- given the estimated height of the tree it could be expected to make contact with HV overhead conductors when it fell

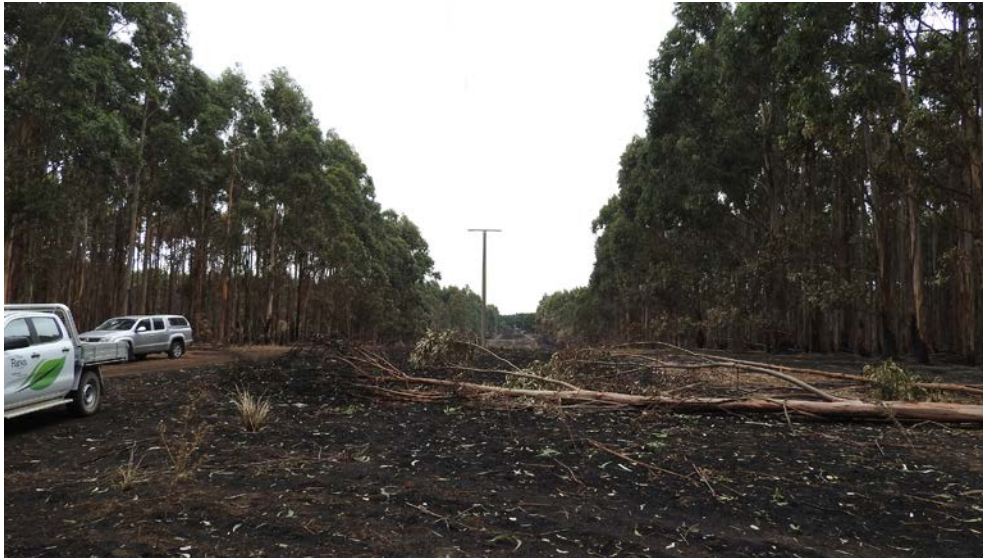
Figure 5: Image showing top of tree under powerline

A review of the photos provided by CFA indicates that there is significant clearance between the plantation trees and the HV conductors.

- a section of the top of the tree that was significantly burnt was positioned under the HV conductor. This placement was directly beneath the section of HV line where new conductor had been repaired. The position also correlated with a burnt section on the ground. This was assumed to be the potential ignition point

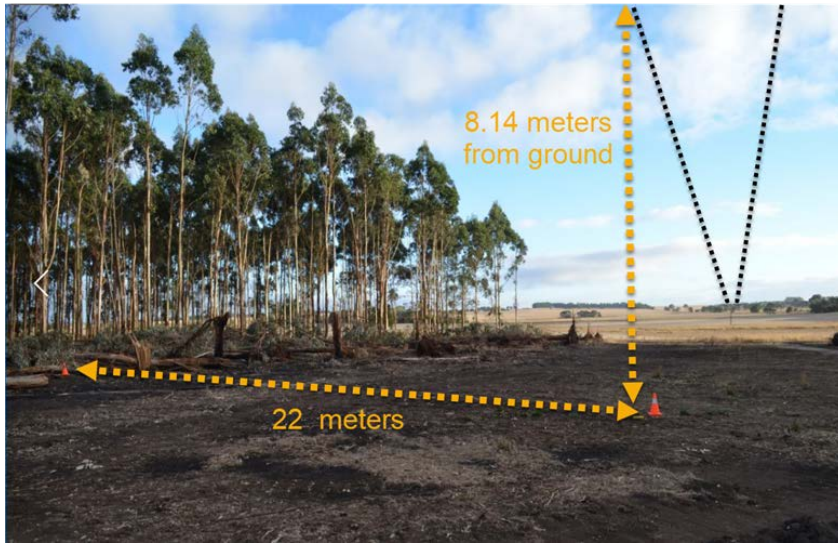
Figure 6: Distance from tree base to OH Line

- the height of the HV conductor at the repaired section was 8.14 metres
- the tree was within the middle two thirds of the span (which is used to calculate the electric line clearance requirements)

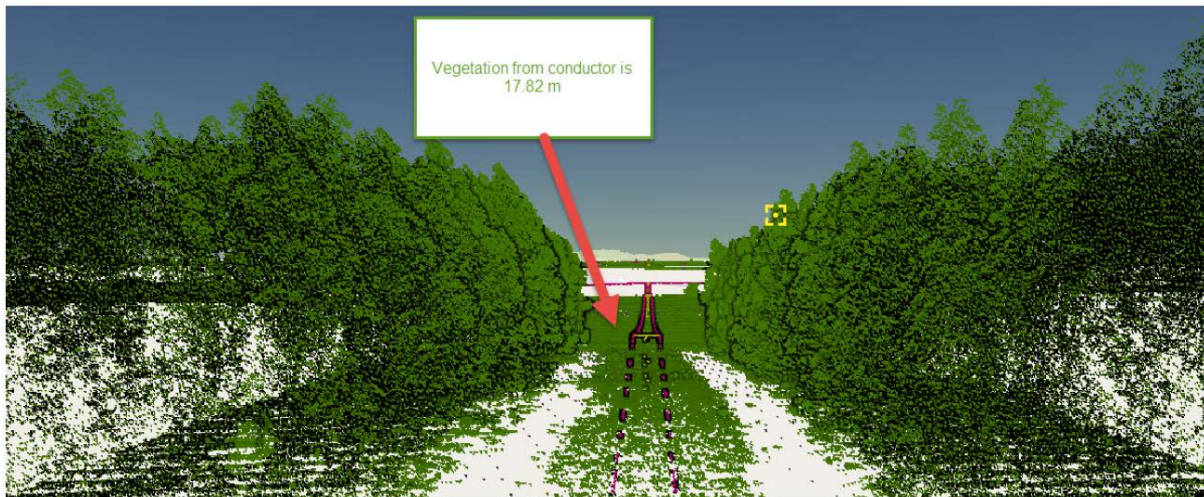
Figure 7: LiDAR image of site provided by Powercor

This indicates that the closest vegetation was assessed at 17.82 metres away from the HV conductor as per Figure 6.

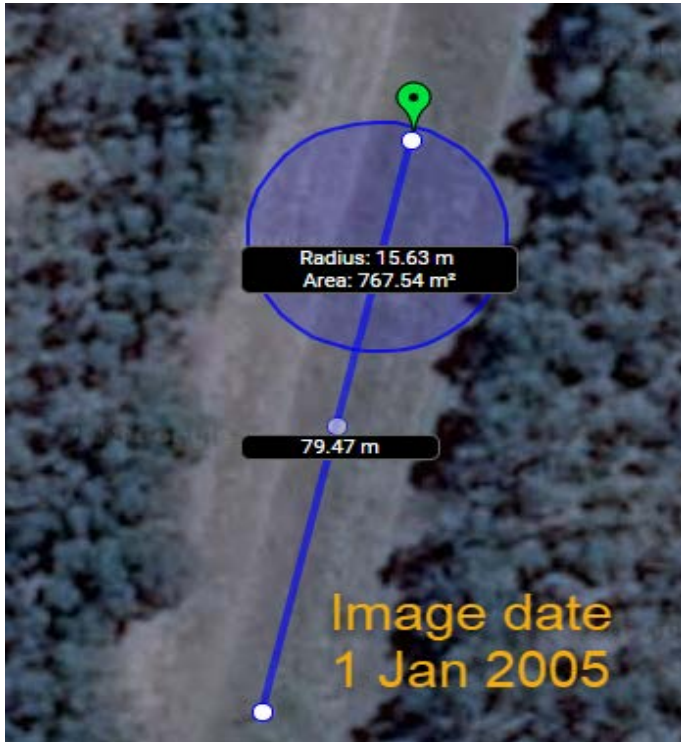
Figure 8: Nearmaps image of area

A search and review of images provided by Nearmap⁴-Photomaps shows the site and span dimensions (1 Jan 2005). The ignition point is approximately 79.4 metres from pole 2 and easement width at approximately 30.20 metres.

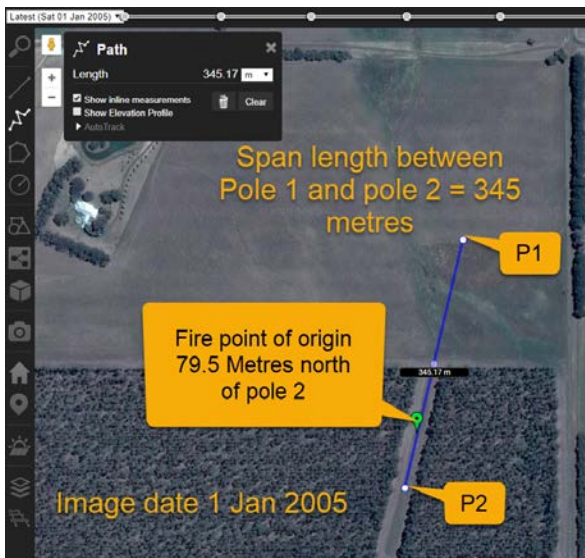
Figure 9: Span information

Span length between P1 and Pole 2 is an estimated 345 metres and vegetation contact is in the middle two thirds (2/3) of the conductor span used for calculating the electric line clearance requirements.

The tree of concern existed within the middle two thirds of the span therefore a minimum clearance distance of 1995 mm was required in all directions from the HV overhead conductors.
