Submission 4th Oct 2022 to ESV's draft United Energy Wood Pole Management Public Report

Prepared by [REDACTED]

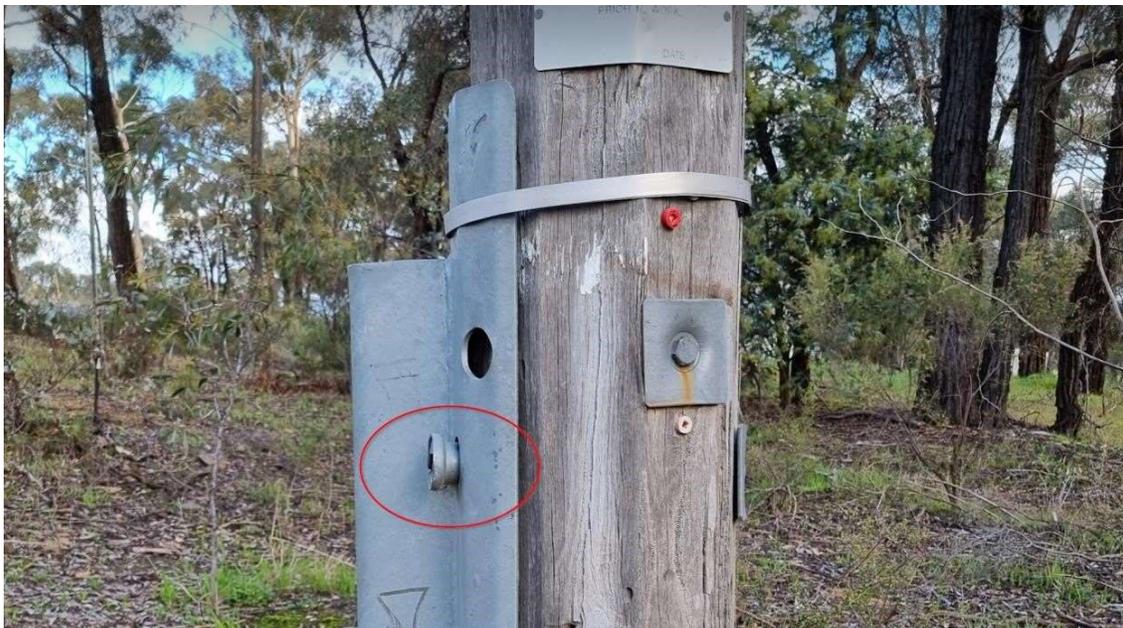
Figure 2 Loose Bolt connection (circled) on a compromised pole

Note: outer fibres compress inwards – reducing the effectiveness and strength of the pole / reinforcement connection
