VEC RESOURCE MANUAL

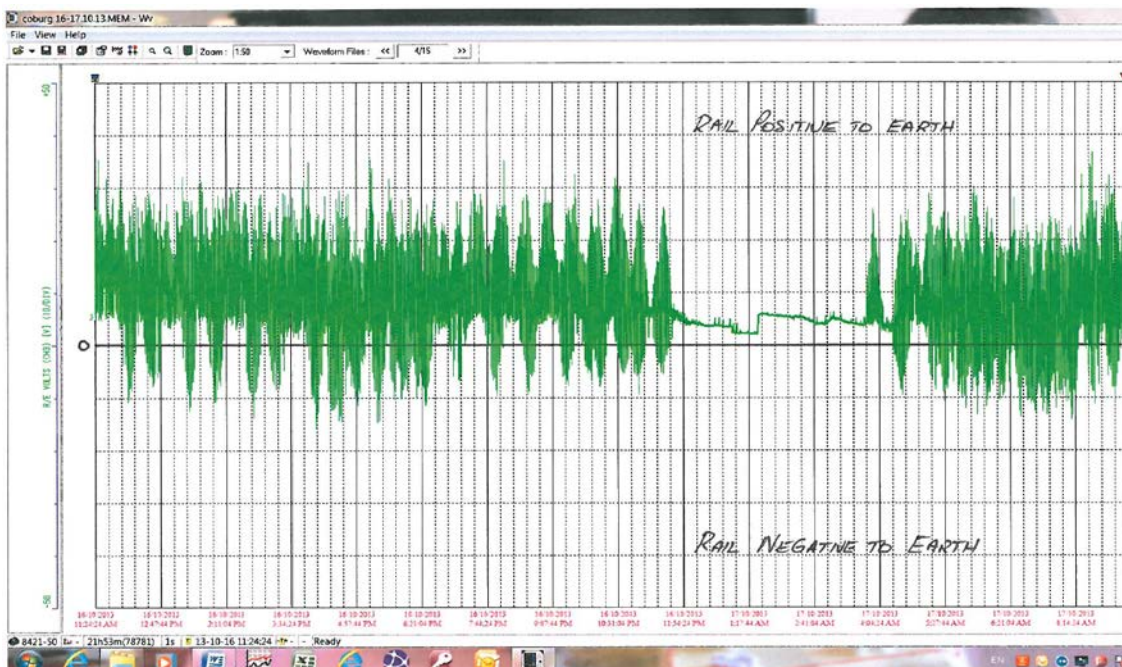
Figure 2 - Chart showing railways rail to earth voltage, including negative excursions due to the regenerative braking trains.

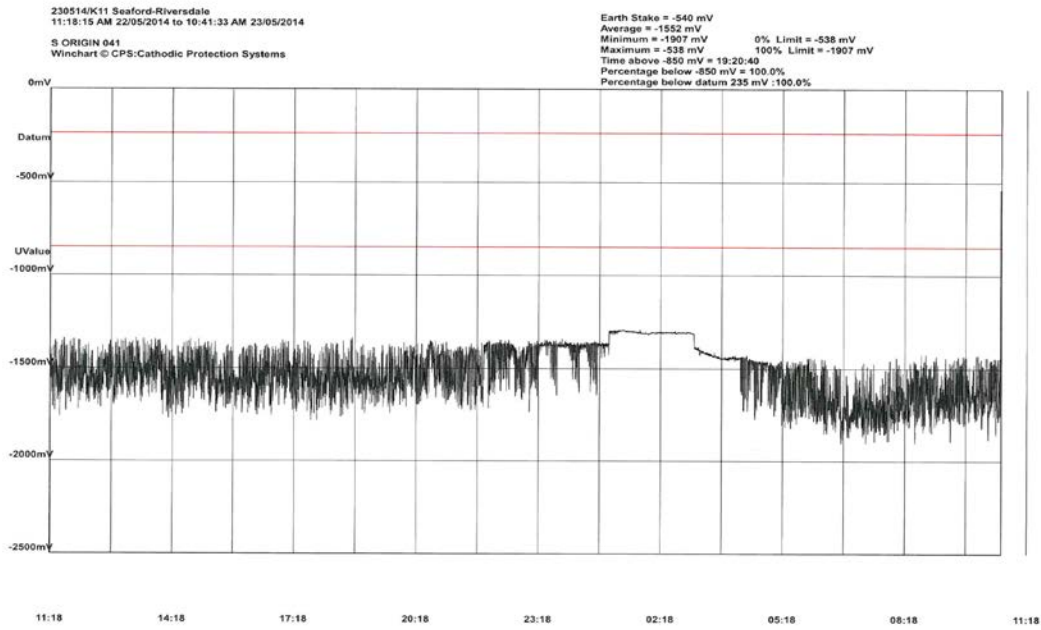
Figure 6 – Typical structure chart showing the results of stray current drainage incorporating a TDU and the effects of the TDU being turned “off” during the quiescent traction period.

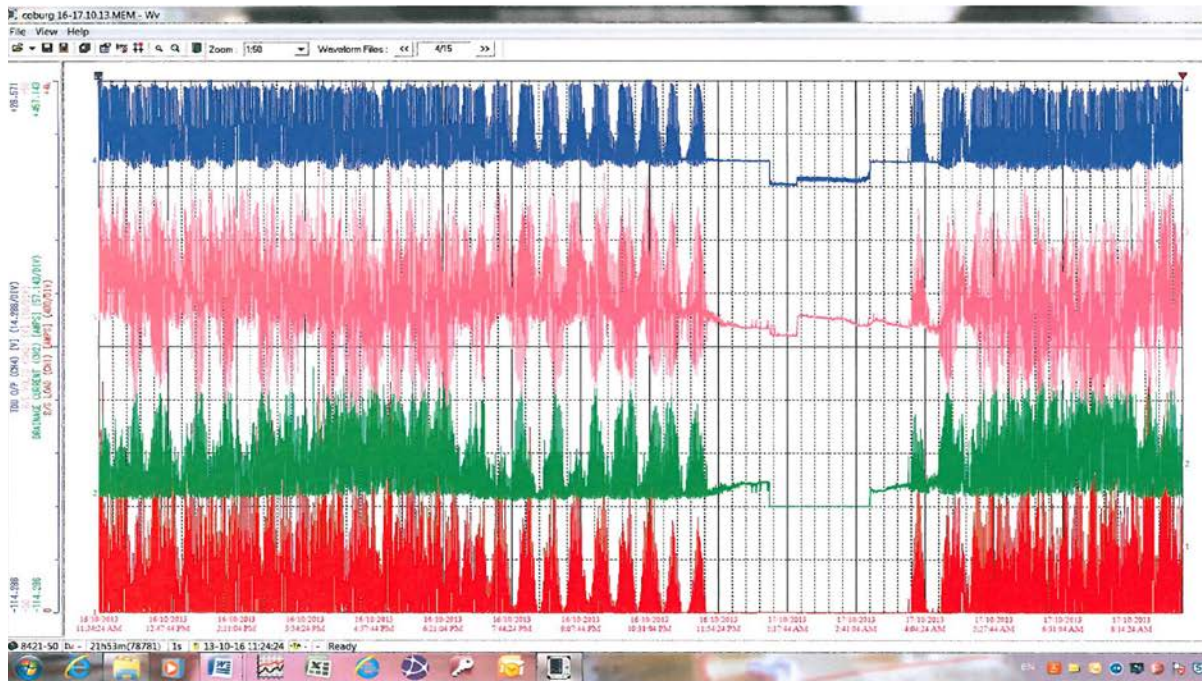
Figure 8 - Chart showing the relationship between substation load, rail to earth voltage, drainage current and TDU output at a railways substation.

The TDU basically comprises a transformer rectifier unit, capable of producing over 100A at up to 30V, controlled by Silicon Controlled Rectifiers (SCR's) triggered by a sensing unit operating according to substation load or rail to earth voltage.

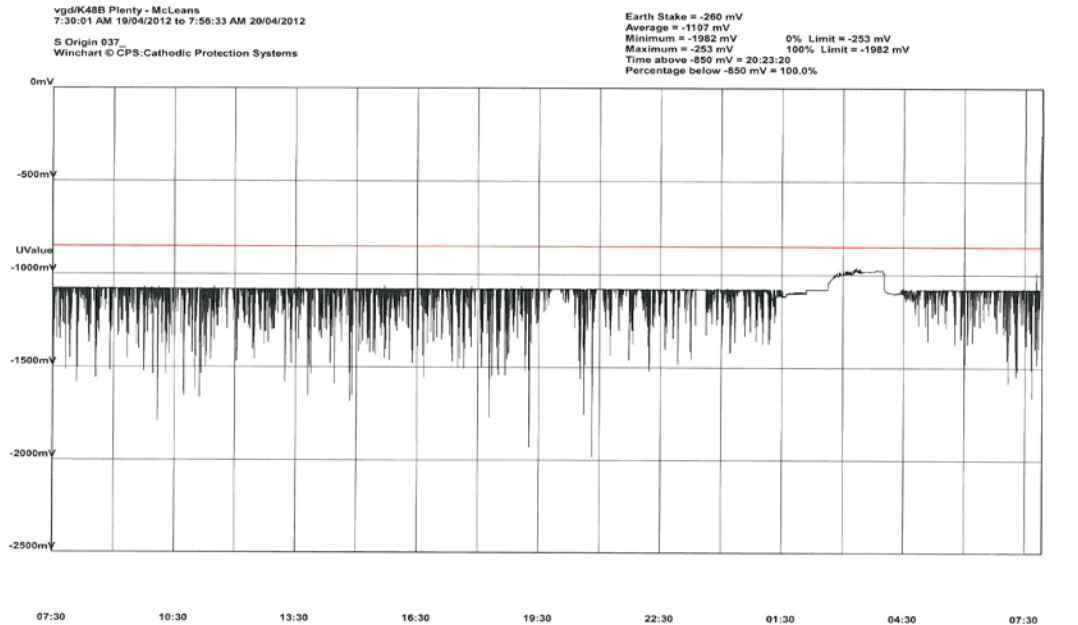
Figure 11 - Typical VCDB drainage chart

The Variable Conductance Drainage Bond (VCDB) senses the potential of the structure and varies the resistance of the drainage bond to allow only that current required to remove the anodic potentials to a non traction reference.

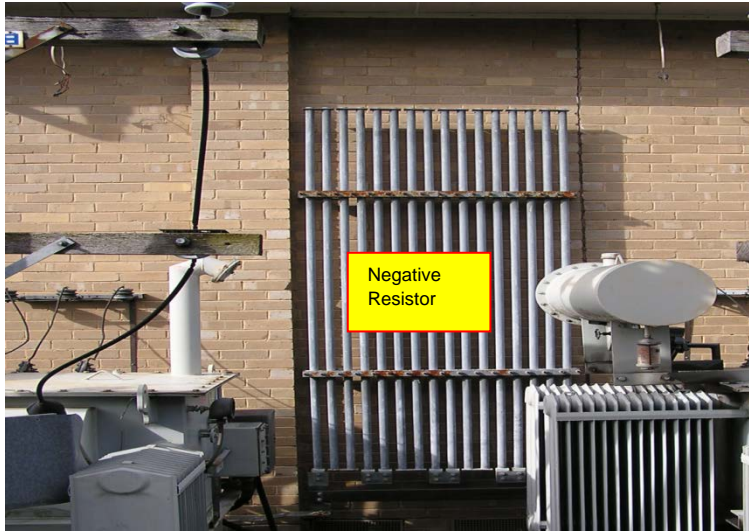
Figure 12 - Typical tramway substation showing negative resistor.

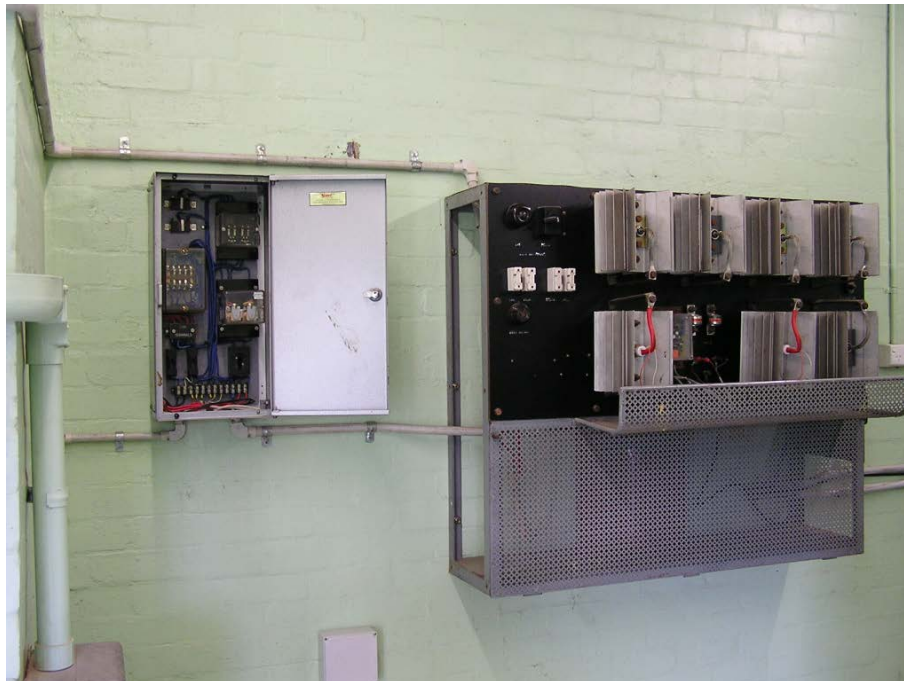
Photograph of a typical TDU installation (old type).

Due to the lack of available room inside the substation, some TDU's at the tramway substations have had to be installed in cabinets adjacent to the outside walls of the substations, Refer Fig 6.

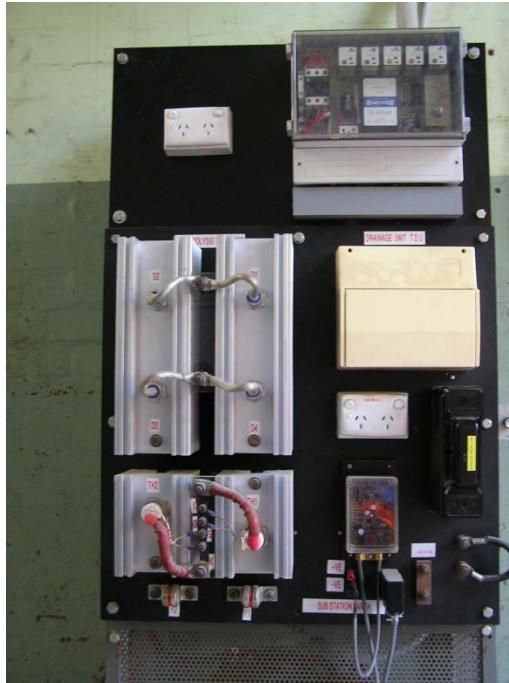
Photograph of a typical TDU installation (new type).

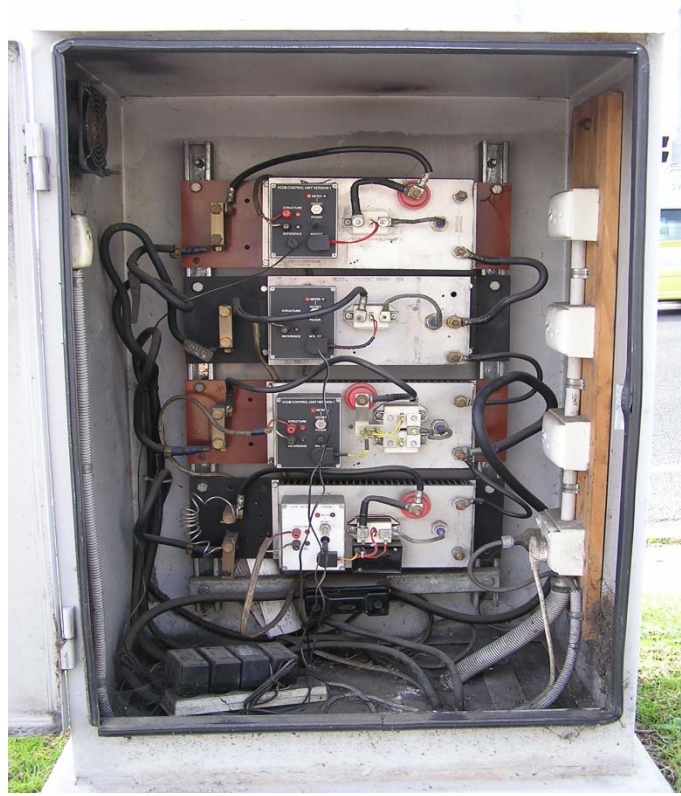
Photograph of typical VCDB installations with DC supply at the substation.

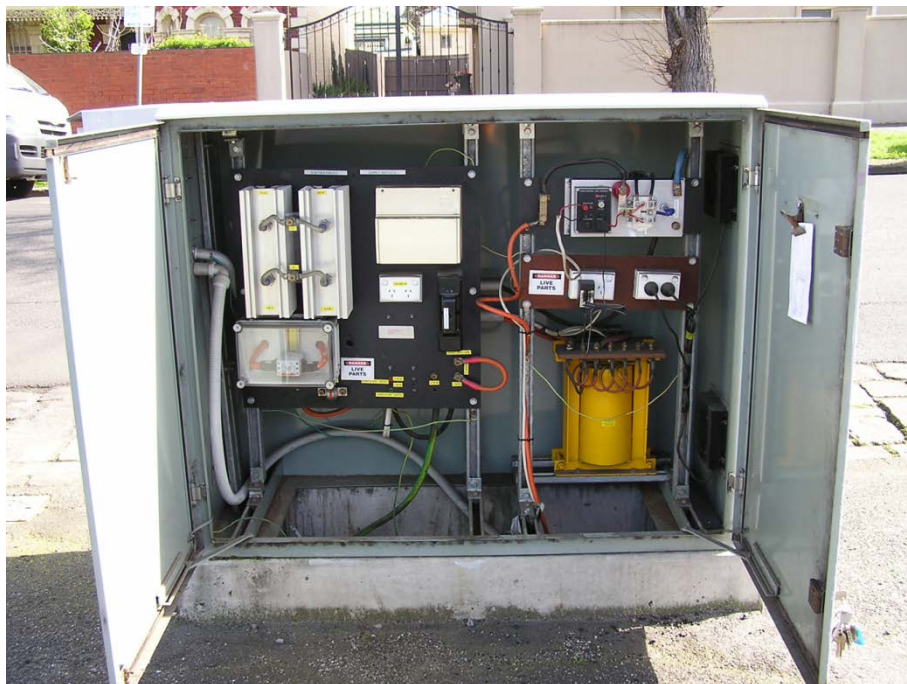
Photograph of typical VCDB installation which includes DC supply.

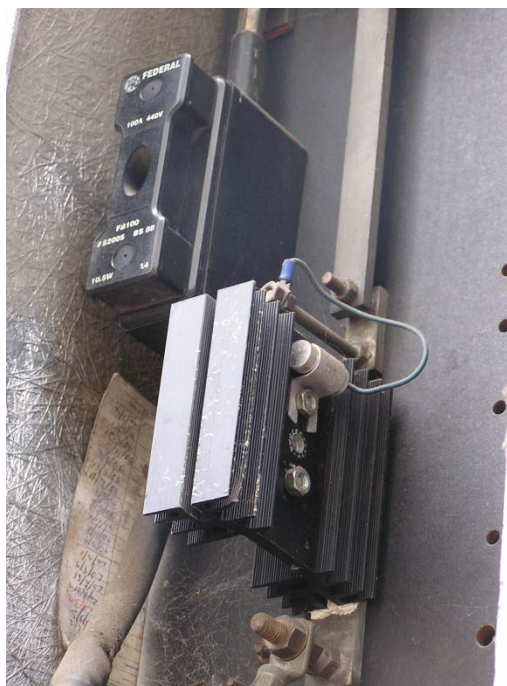
Photograph of typical noise suppression capacitor

The most common value of those installed is 0.47 Microfarad.

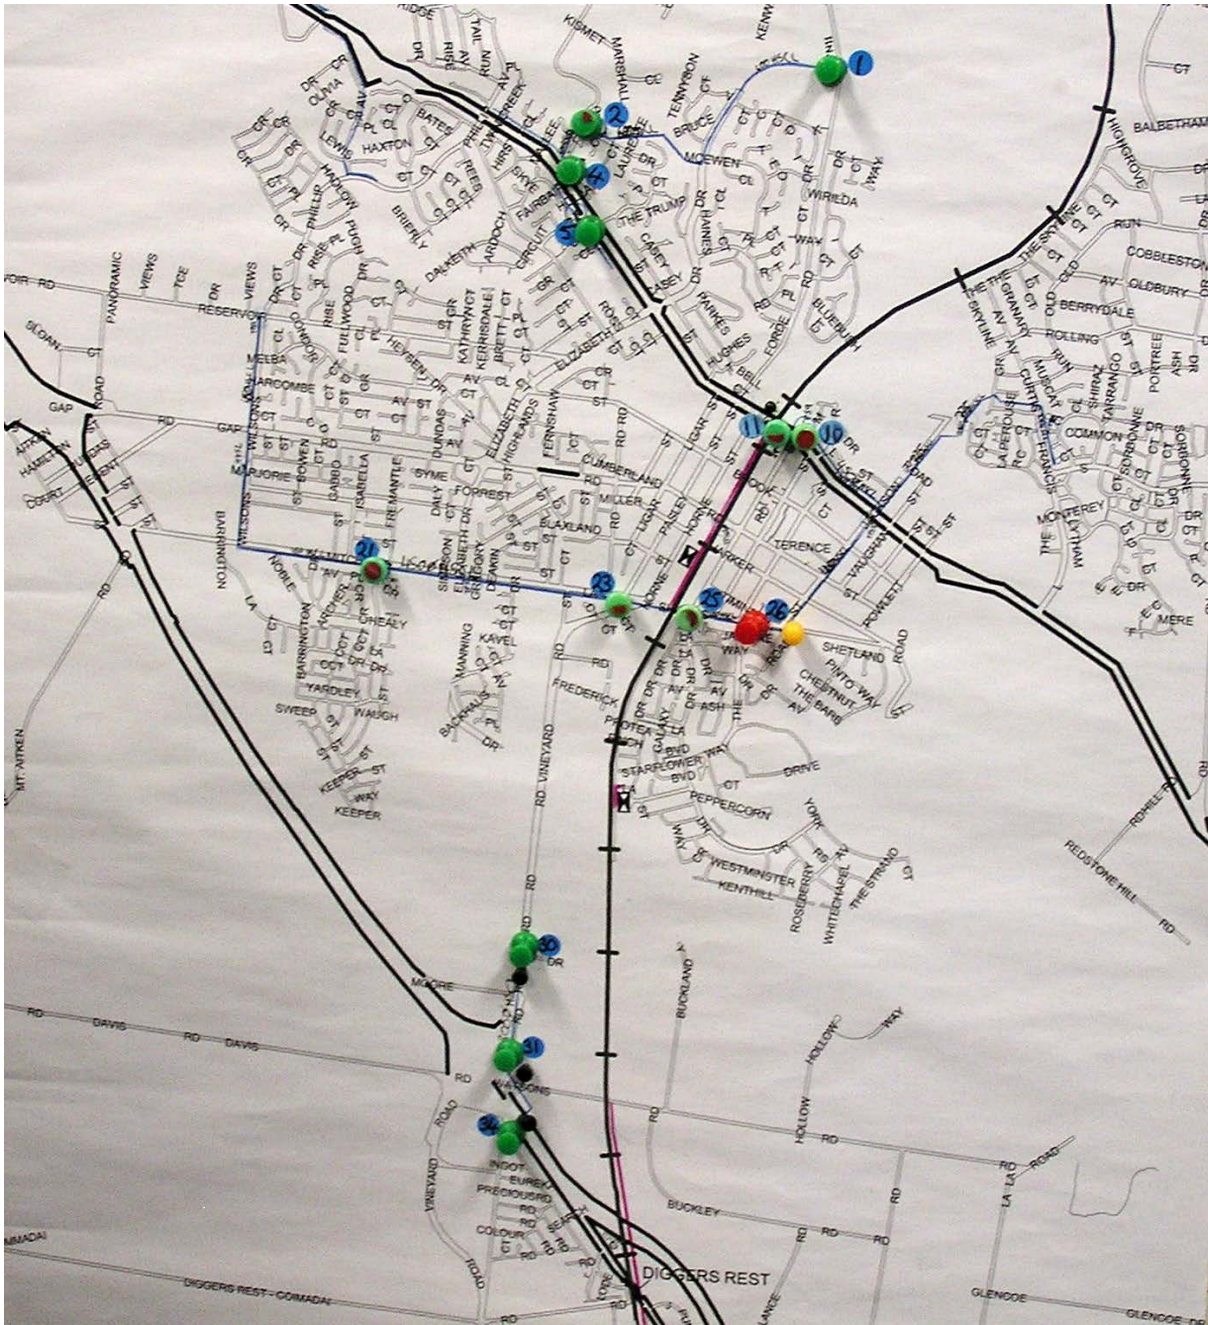
A typical map showing drainage bonds, electrolysis feeders, test points, ICCP systems and underground structures as used during combined area testing.

During the preparation of an area test, maps are produced that show the structures under test, the configuration of the drainage system and traction substations. These maps can also have the location of insulating flanges, regulator pits, valves, ICCP systems etc. The condition of structures as assessed by the above criteria are shown on the maps, with the amount of red on a green pin indication how anodic a structure has been assessed. Below is a sample of an area test map.

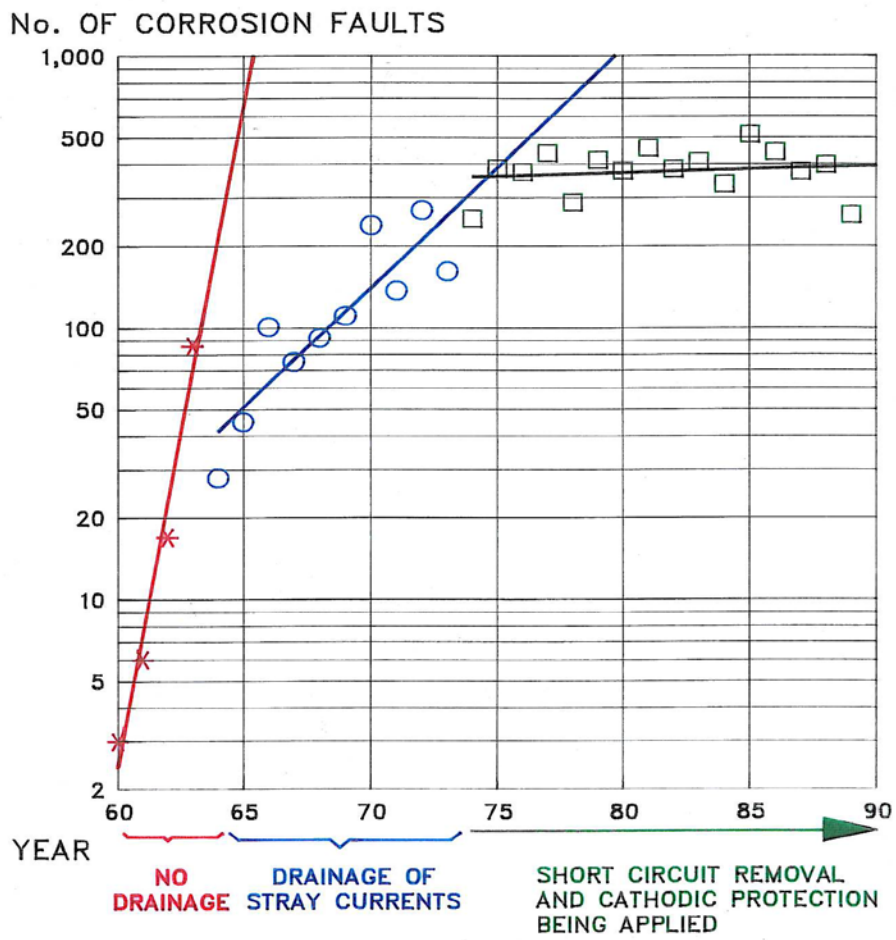
Figure 1

CORROSION FAULTS ON H.P. DISTRIBUTION SYSTEM

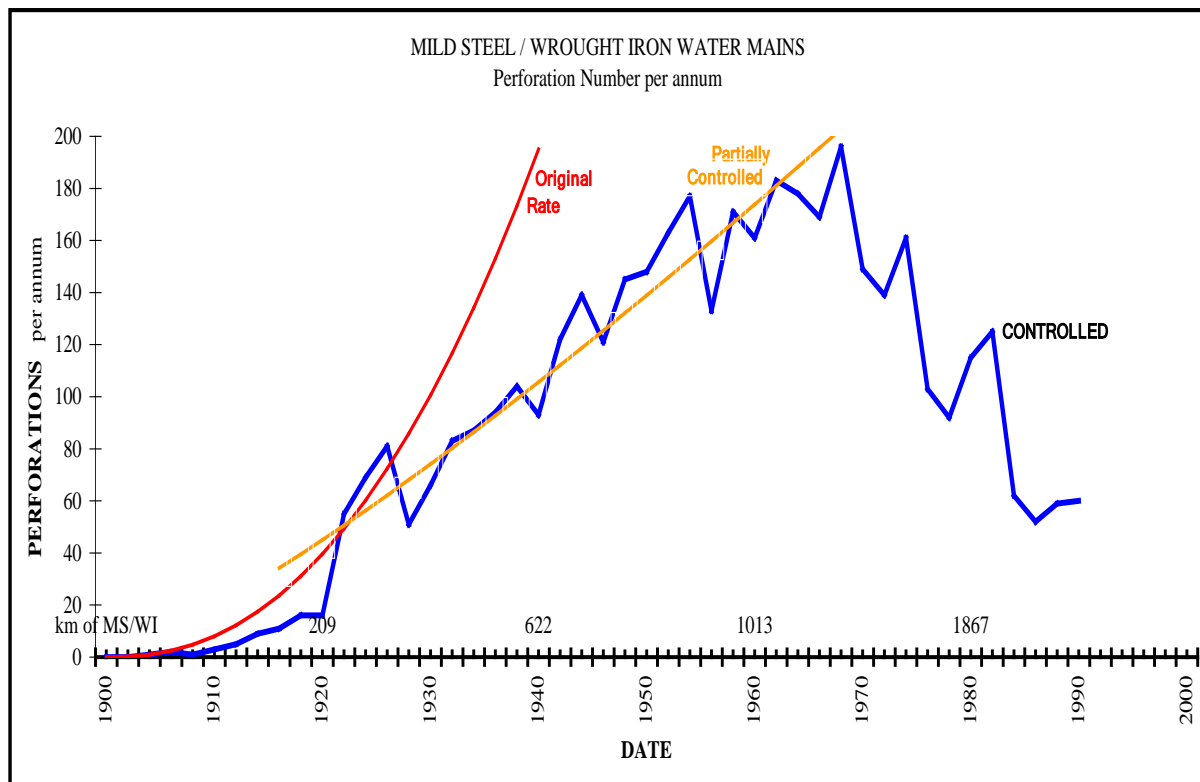
Fig. 1.1

Perforation Rate per Annum

This is shown on the Figure 1.1 – Perforation rate per annum.

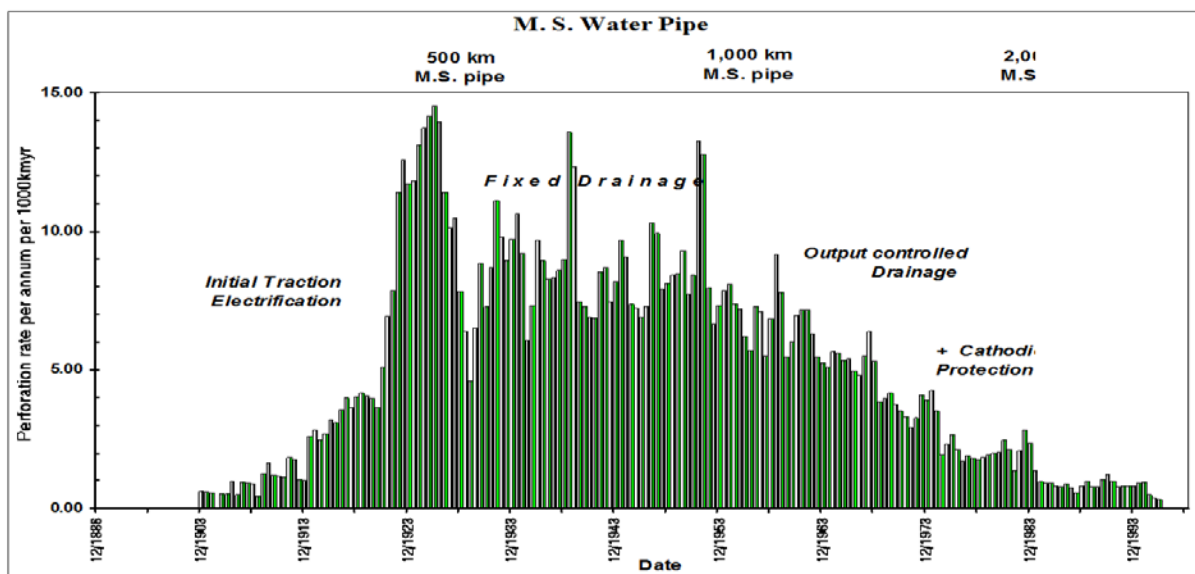
Fig. 1.2. Perforation Rates per Annum per km/year

A more realistic analysis must take account of the accumulated 'exposure time' of the pipes to the stray traction currents, i.e., how long have they been in that environment. When the data is modified to include the pipe exposure factor, the perforations per annum per 100km.year show the same 3 phases but with some useful variations, see Figure 1.2
