Insulated LV electric line cut with hedge trimmer

Vegetation Management Work

9 January 2024

Safety alert

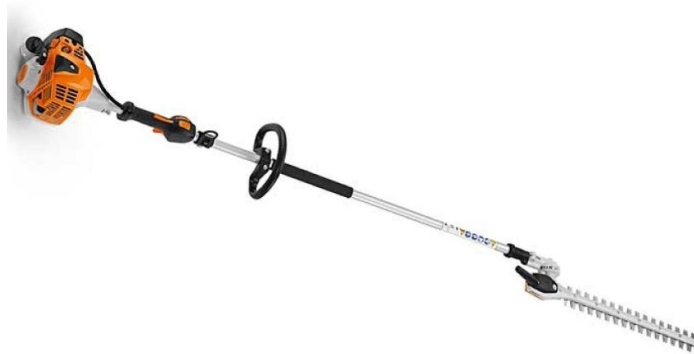
A gardener was conducting tree trimming work at a private residence in a low bushfire risk area (**LBRA**). The work was being performed by a gardener who was using an extendable pole mounted hedge trimmer (**hedger**) similar to that pictured below.
