Gazette Fire Ignition

17 March 2018

**Tree failure 992 Twomeys Bridge
Road, Yatchaw**

Technical investigation report

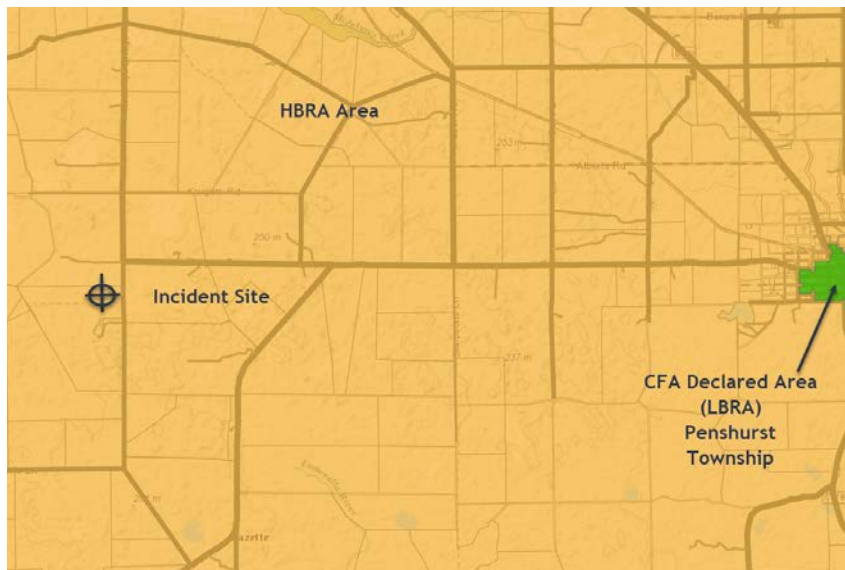
Figure 2: Incident site map

Figure 2 shows a map of the incident site in relation to the CFA declared Low Bushfire Risk Area (in green) and the HBRA area (in amber).
